<b>Client</b>	John Smith
<b>Property Address</b>	1234 Main St. Anywhere, CA 92264
<b>Survey Date</b>	February 26, 2005

**RED LIGHTS - Issues that should be considered for immediate attention**

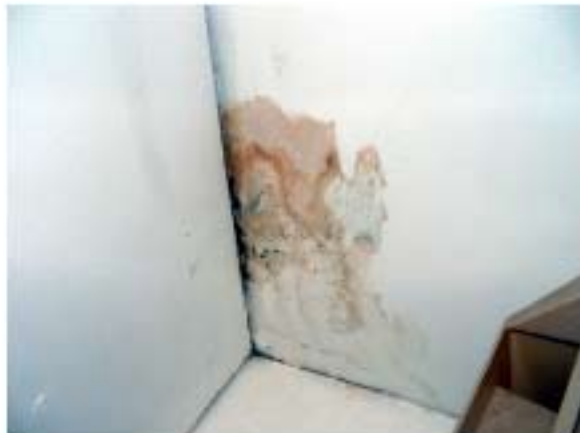
North Wall Behind Dresser

● **Bedroom**

Evidence of microbial organism observed.

The only way to determine the toxicity of a given mold is through laboratory analysis. Sampling and analysis are suggested for this substance or of the air surrounding the area.

The method of clean up or remediation of mold is dependent upon the type of molds involved. Certain molds could potentially present health risks to those involved in removal. Consider waiting for the laboratory results before developing a strategy for removal.

A sample of this substance was collected for laboratory analysis by client request. This sample will be referenced on the independent laboratory report:

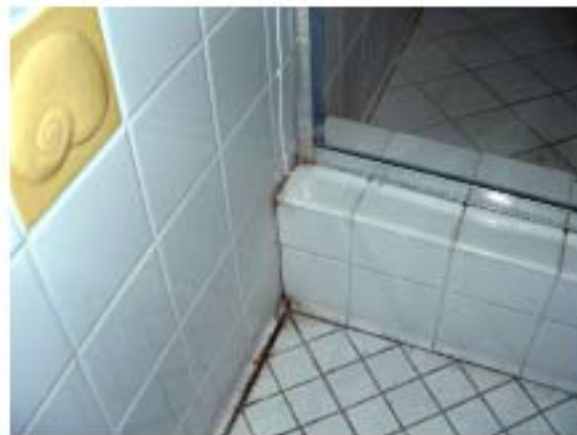
NW Corner of Guest Bath

● **Bathroom - Room**

Evidence of water damage observed.

Water damage is the leading cause of mold infiltration. Identification and repair of the source is recommended. Replacement of the damaged materials is also suggested.

If mold-like substance is discovered during repair, DO NOT CONTINUE REPAIR until substance is tested for toxicity by laboratory analysis.

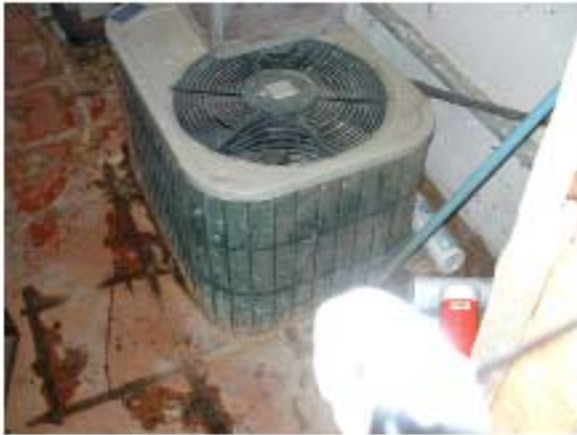
Walkway on South Side

● **HVAC - Room**

Evidence of water damage observed.

Water damage is the leading cause of mold infiltration. Identification and repair of the source is recommended. Replacement of the damaged materials is also suggested.

If mold-like substance is discovered during repair, **DO NOT CONTINUE REPAIR** until substance is tested for toxicity by laboratory analysis.

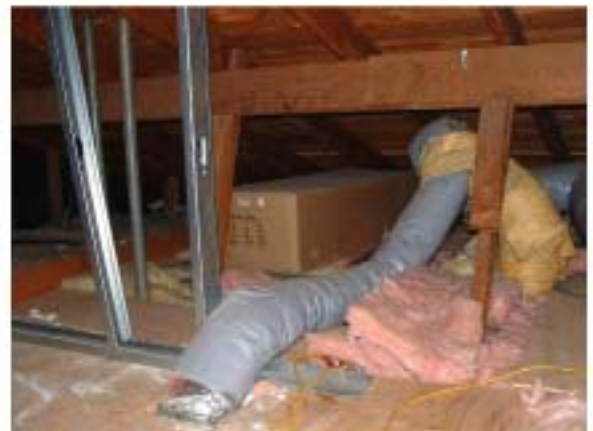
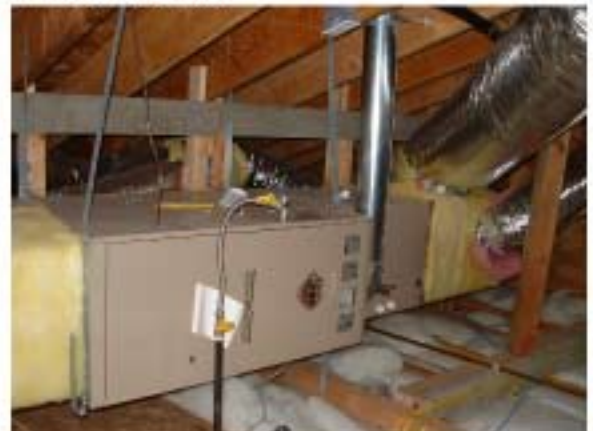
● **Attic**

Evidence of microbial organism observed.

The only way to determine the toxicity of a given mold is through laboratory analysis. Sampling and analysis are suggested for this substance or of the air surrounding the area.

The method of clean up or remediation of mold is dependent upon the type of molds involved. Certain molds could potentially present health risks to those involved in removal. Consider waiting for the laboratory results before developing a strategy for removal.

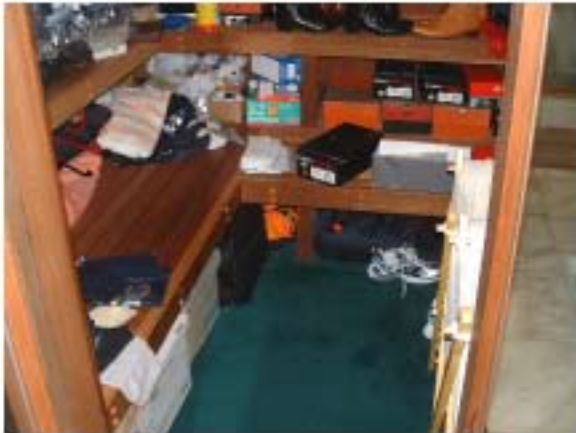
● **Hall Closet**

There is a stale or musty smell in this area.

Musty odors may indicate an undiscovered water or mold issue.

Air sampling might provide more information regarding the indoor air quality in this area.

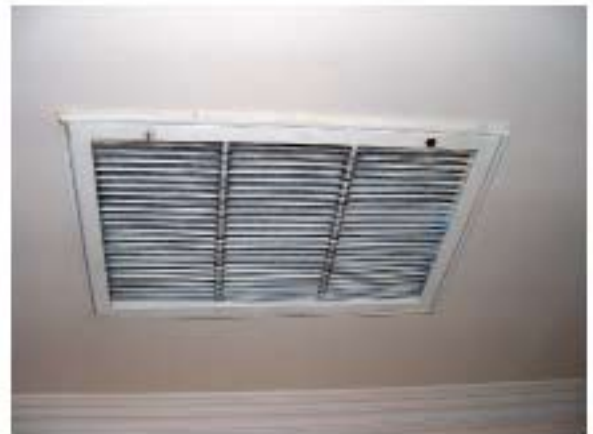
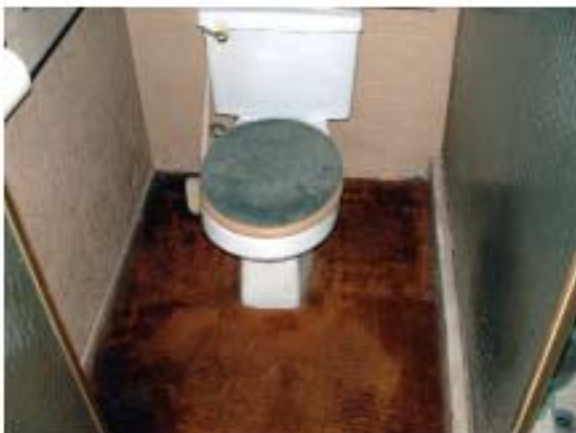
● **Bathroom - Room**

There is carpeting in bathroom.

Steam and moisture can easily penetrate carpeting potentially creating both an ideal environment and hiding place for mold.

Consider replacing carpeting with a flooring alternative that will not absorb moisture.

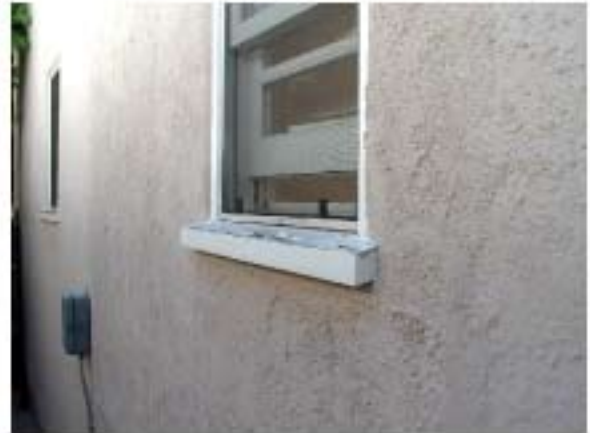
Exterior Master Bath

**● Bathroom - Room**

It appears that window may be poorly seal, potentially allowing water to seep into structure.

Water seeping into structure can create an environment for mold growth.

Consider consulting a licensed contractor for evaluation and remedy.

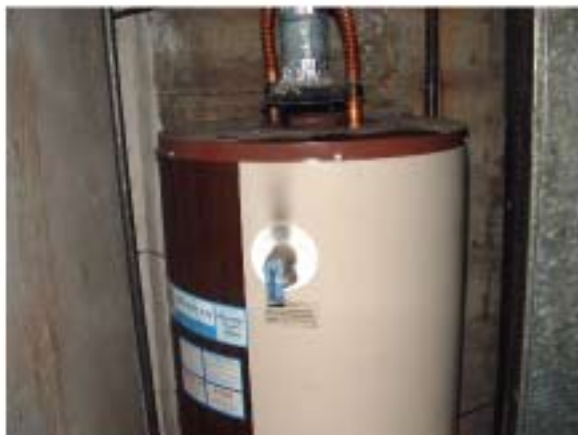
**● Water Heater - Unit**

The pressure release valve on the water heater is not terminated into plumbing system or out of structure, potentially allowing steam and water to seep into walls and floor.

Water flowing into walls and floor can create an ideal environment for mold growth.

Consider consulting an authorized service provider for evaluation and remedy.

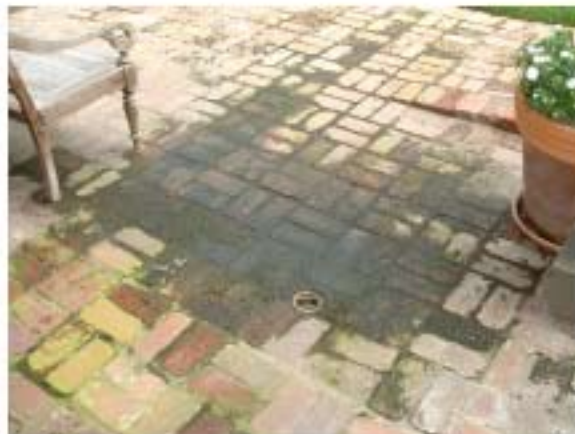
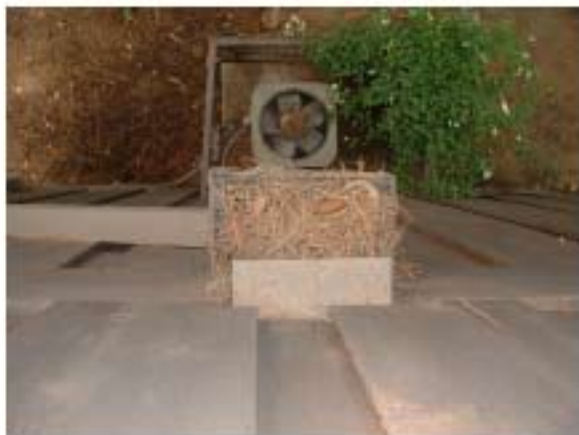
● **Downspouts**

Downspouts appear to be blocked.

● **Gutters**

Sections of rain gutters are missing, potentially allowing water to flow against exterior of structure.

Water flowing against exterior walls can potentially penetrate surface cracks increasing the possibility of dampness and mold growth inside walls.

Consider a developing a regular maintenance schedule to keep downspouts clear.

Consider consulting a licensed contractor for evaluation and remedy.

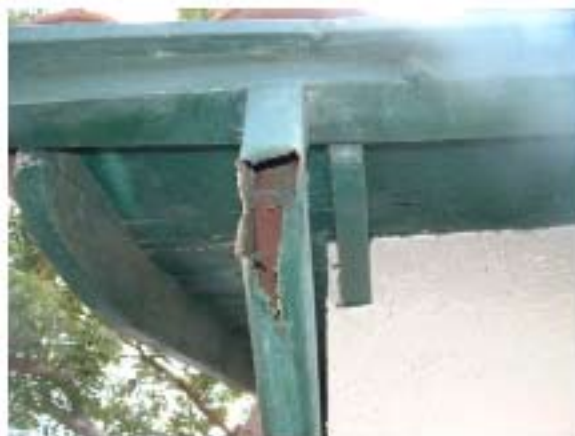
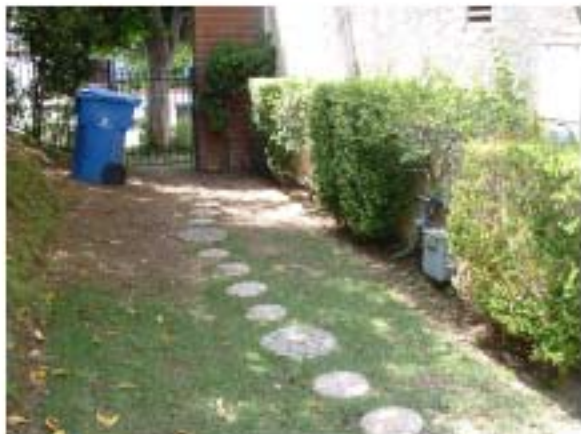
● **Grading**

Property appears to be graded in a way that slopes toward the structure, potentially allowing water to flow near or against exterior walls.

Water flowing against exterior walls can potentially penetrate surface cracks increasing the possibility of dampness and mold growth inside walls.

Consider consulting a licensed contractor for evaluation and remedy.

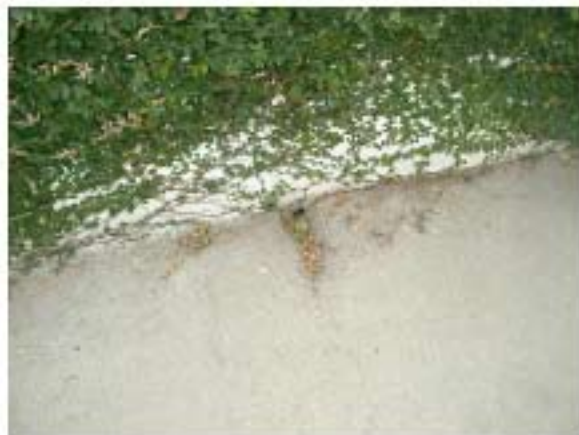
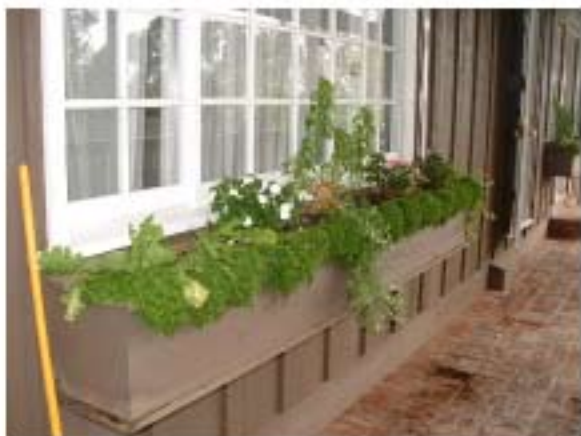
● **Planters**

Planters are mounted onto exterior walls.

Items bolted onto exterior walls can allow water to penetrate into structure at bolt sites. Moisture intrusion of this type can potentially create an environment friendly to mold growth within walls.

Consider having a licensed contractor remove installation and patch walls.
